REPORT OF INVESTIGATIONS/1992

Effects of Horizontal Stress Related to Stream Valleys on the Stability of Coal Mine Openings

Report of Investigations 9413

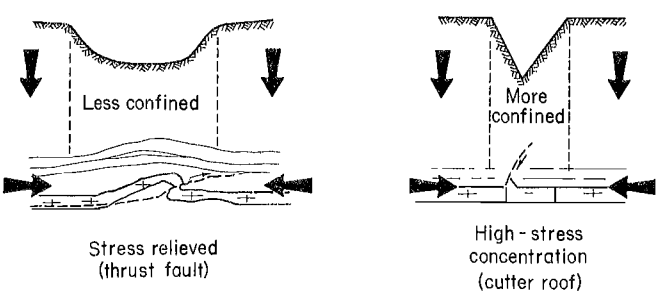
It is thought that immature or V-notched valleys tend to concentrate horizontal stresses near their apex, and produce active stress-related failures such as cutter roof, kink roof, and snap top (*11*). Hill verified the existence of high horizontal stress beneath a V-notched valley in West Virginia as predicted by a numerical model (*12*). Instead of concentrating stresses, as in a V-notch confined valley, older more mature valleys appear to be in a stress-relieved state. It is thought that broad, flat-bottomed valleys may be stress relieved because of valley rebound due to unloading as well as the transfer of stress laterally due to loading of the valley walls. Figure 1 shows how relatively less confined valley floor members beneath the broad valley can move when subjected to lateral forces and thereby dissipate those transmitted forces. The figure also shows how

Figure 1.—Theoretical effect of valley shape on horizontal stress and roof control at depth.

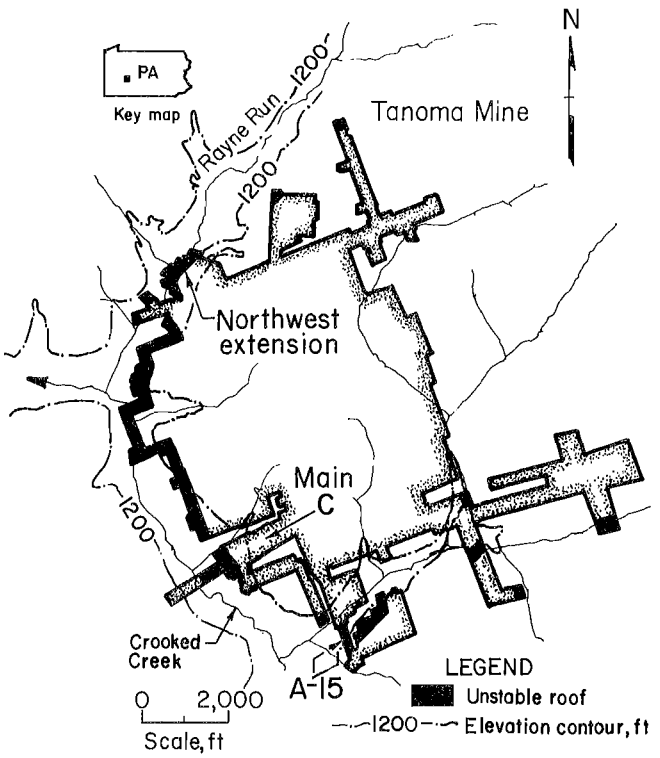
Figure 3.—Tanoma Mine outline and relationship of unstable roof to surface drainage.

of mine ranges between 120 and 475 ft. Figure 3 shows the mine outline with local drainage overlayed. Also, shown are areas of roof instability as reported by the operators. The mine historically has experienced extremely difficult roof control problems when trying to advance its western sections beneath Crooked Creek and Rayne Run. Mining problems under the valley include extreme water leakage, soft bottom, slip planes, and joints associated with roof falls. Heavy supplemental support, including steel legs and crossbar sets, straps, and combination bolts, have been unable to control the roof. Poor roof conditions also exist beneath some of the smaller tributaries overlying other parts of the property. Compression failures, aggravated by channel washouts, water leakage, and soft bottom, characterize roof conditions beneath drainage at Tanoma Mine.

A similar coalbed discontinuity in the northwest extension terminates numerous entries (fig. 3). Other entries remain in coal, but are terminated due to poor roof conditions. Here the coalbed is forced downward due to a channel deposit overhead. Prominent, broad slip planes exit the roof at 45° isolating roof blocks which then drop out. Many of the roof control problems beneath this valley are attributed to this paleochannel and its disturbed margins, but the primary cause of poor roof quality is horizontal stress relief.

Mining section A-15 crosses beneath a tributary of Crooked Creek (fig. 3). The development was necked down to three entries because of unstable roof rock and excessive water leakage. In addition, larger pillars were used to stabilize the hazardous zone. The valley bottom at this point is 400 to 500 ft across, with approximately 284 ft of overburden. Again, the roof instability in this section appears to be a result of horizontal compression perpendicular to the trend of the valley. Bedding plane faults parallel to the valley cause the major roof falls. Throughout the zone of unstable roof, the faults curve upward and intersect to isolate blocks of roof which then fall into the mine openings (fig. 5). Faults flatten parallel to the coalbed and rarely offset it. Slippage has occurred on numerous planes in the siltstone roof. Movement is indicated by broad, grooved, slickensided planes and by gouge zones up to several inches thick.

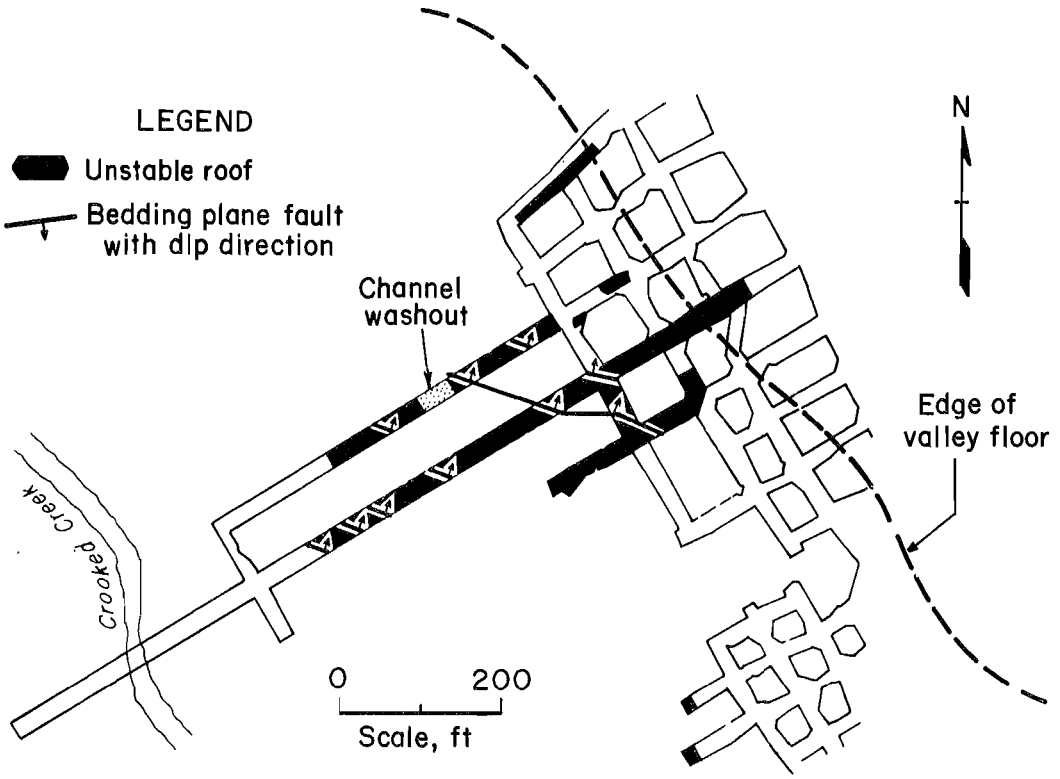
Figure 4.—Main C section of Tanoma Mine with unstable roof occurring in valley bottom.

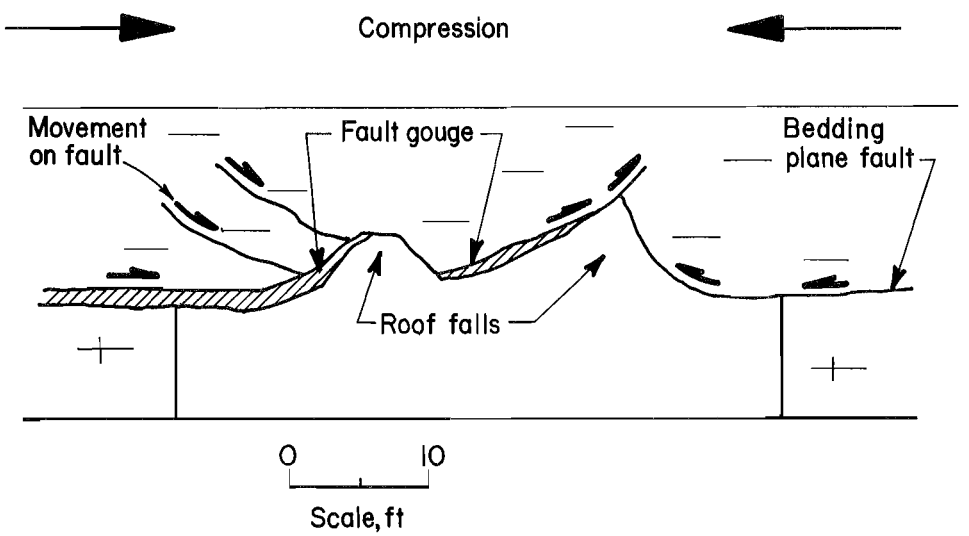
Figure 5.—Horizontal slippage and roof failure in Tanoma Mine caused by compression beneath valley.

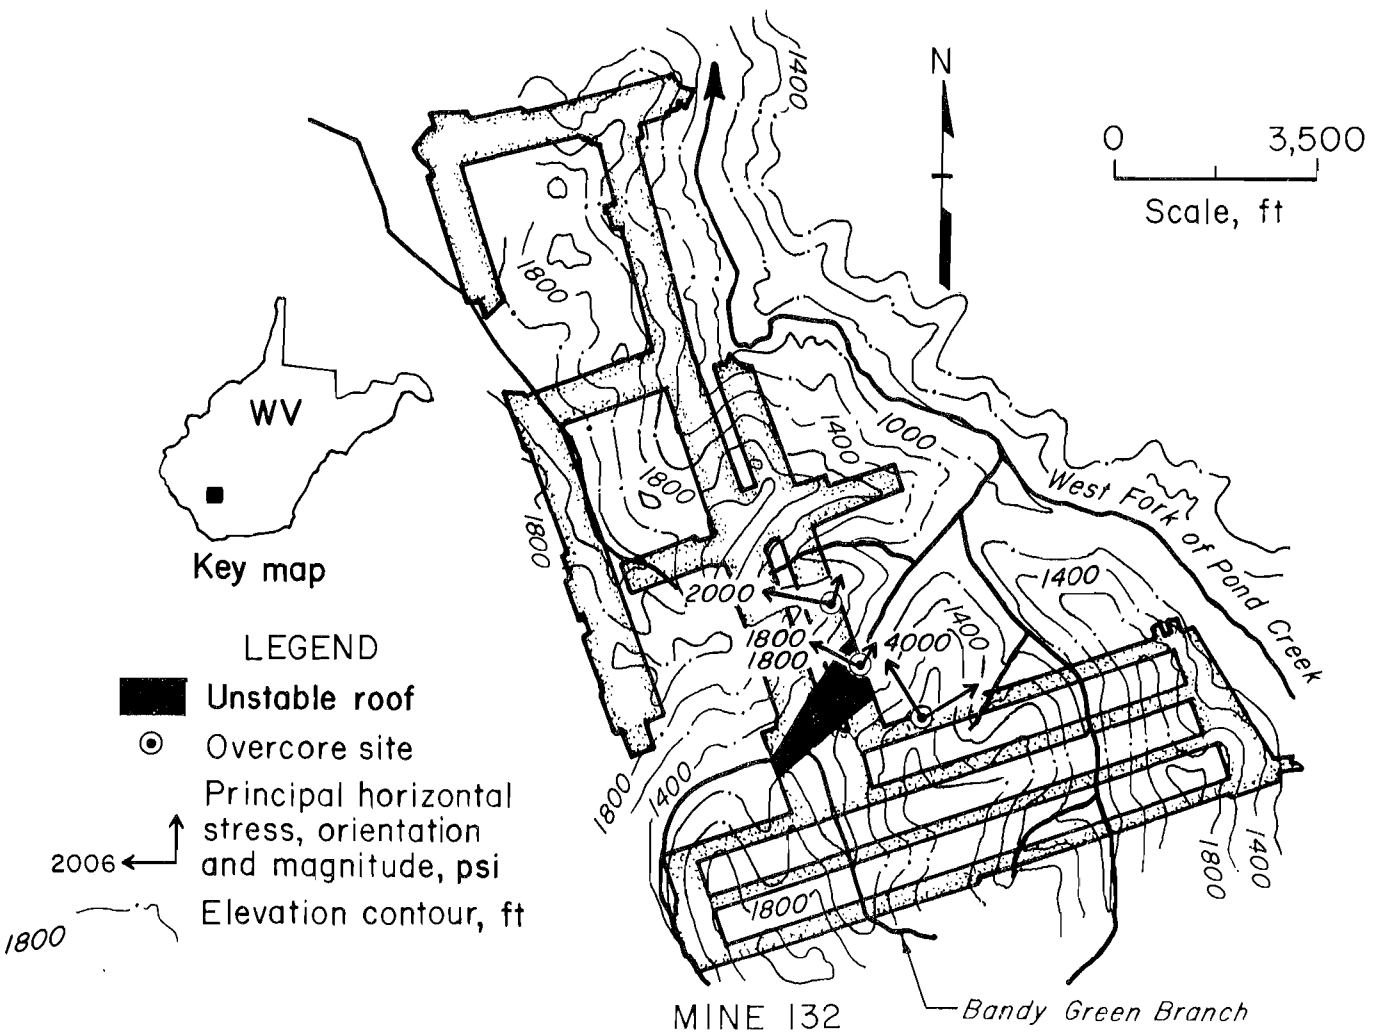
Figure 6.—Mine 132 outline and relationship of unstable roof to surface drainage, and results of horizontal stress measurements.

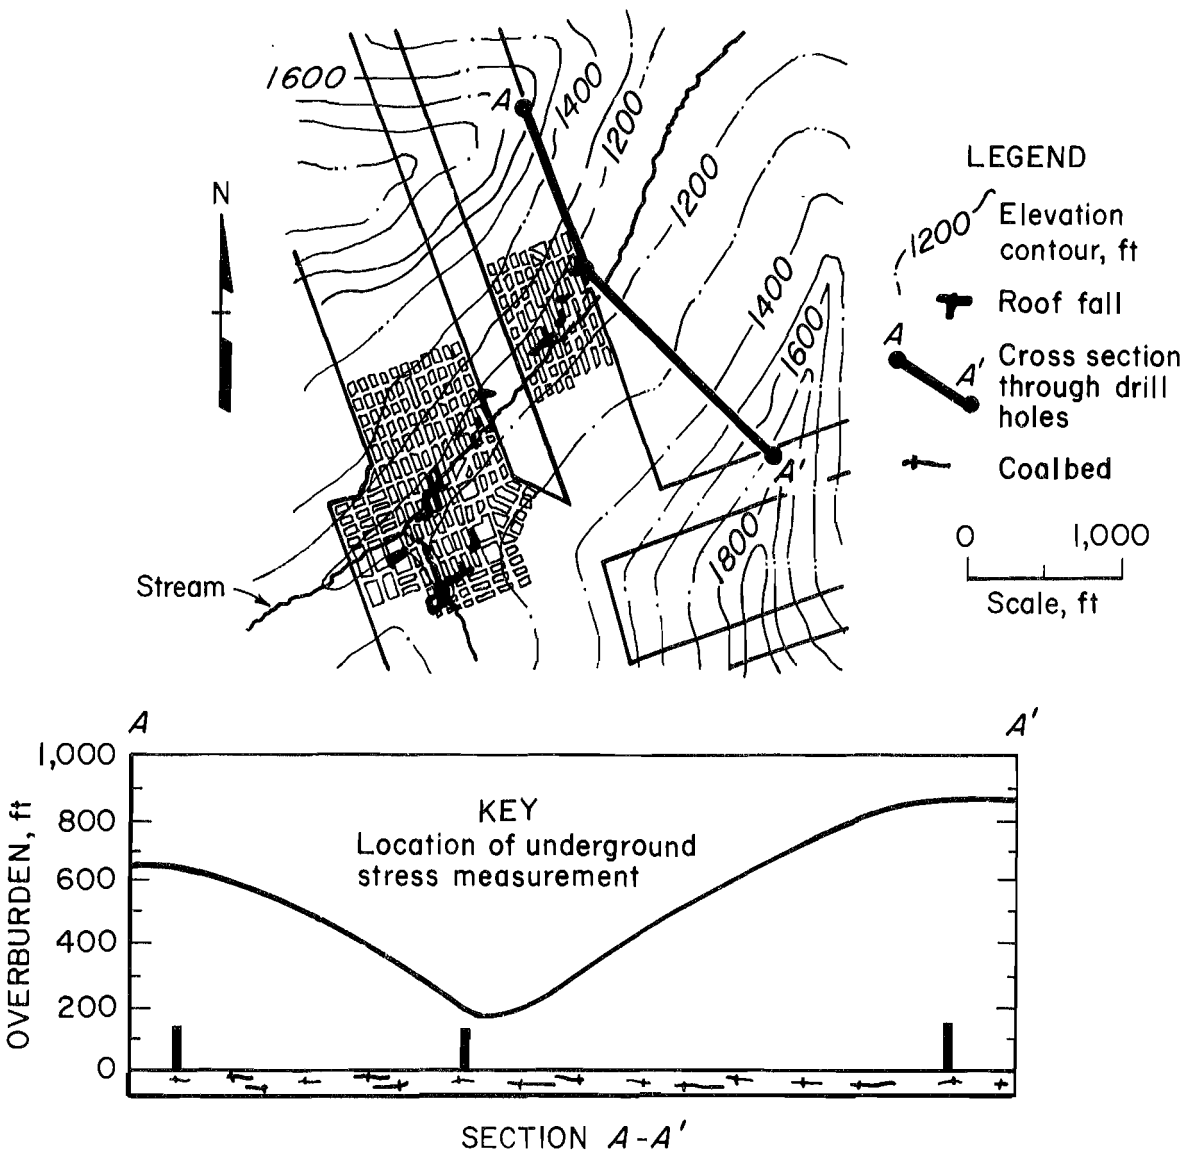
Figure 7 is a map of roof conditions beneath Bandy Green Branch. The zone of roof instability coincides with the valley bottom. Roof falls more than 100 ft long and more than 20 ft high are common. Once again, bedding plane faults are the cause of roof failure. These horizontal failures are similar to those observed at the Tanoma Mine (section A-15 and Main C). Bedding plane faults also curve into the roof and their linear traces parallel the valley trend. As illustrated in figure 5, horizontal slippage occurs in both directions perpendicular to the fault traces and isolates roof blocks which then fall into the mine

Figure 7.—Map of roof failure beneath Bandy Green Branch and location of overcore holes.

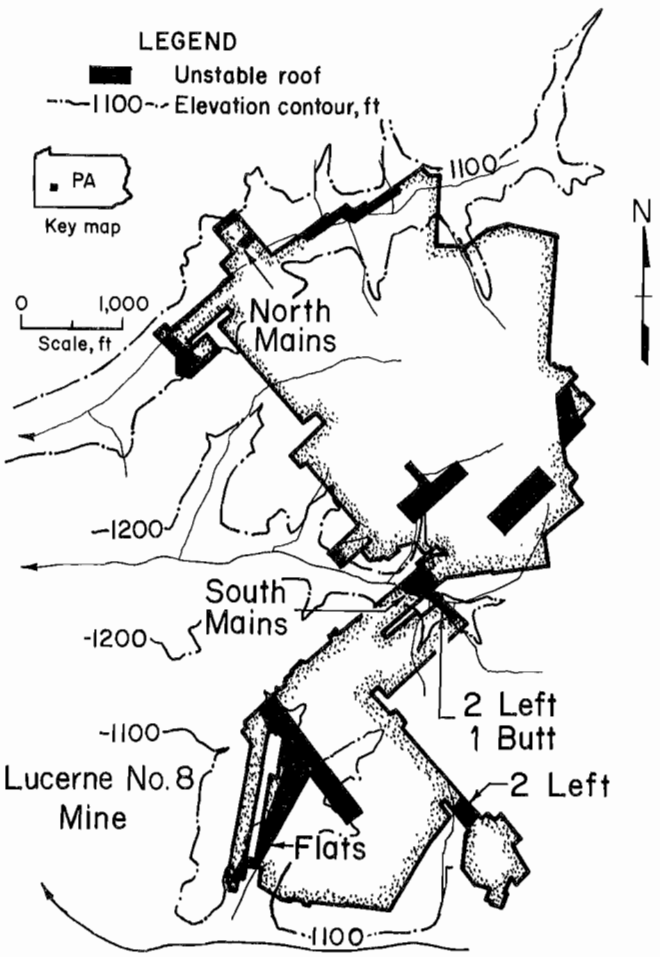
Figure 8 shows the mine outline with surface drainage overlayed. Unstable roof rock conditions coincide with several drainage basins, but not all. Thrust faults and bedding plane faults are responsible for roof instability in

Figure 8.—Lucerne No. 8 Mine outline and relationship of unstable roof to surface drainage.

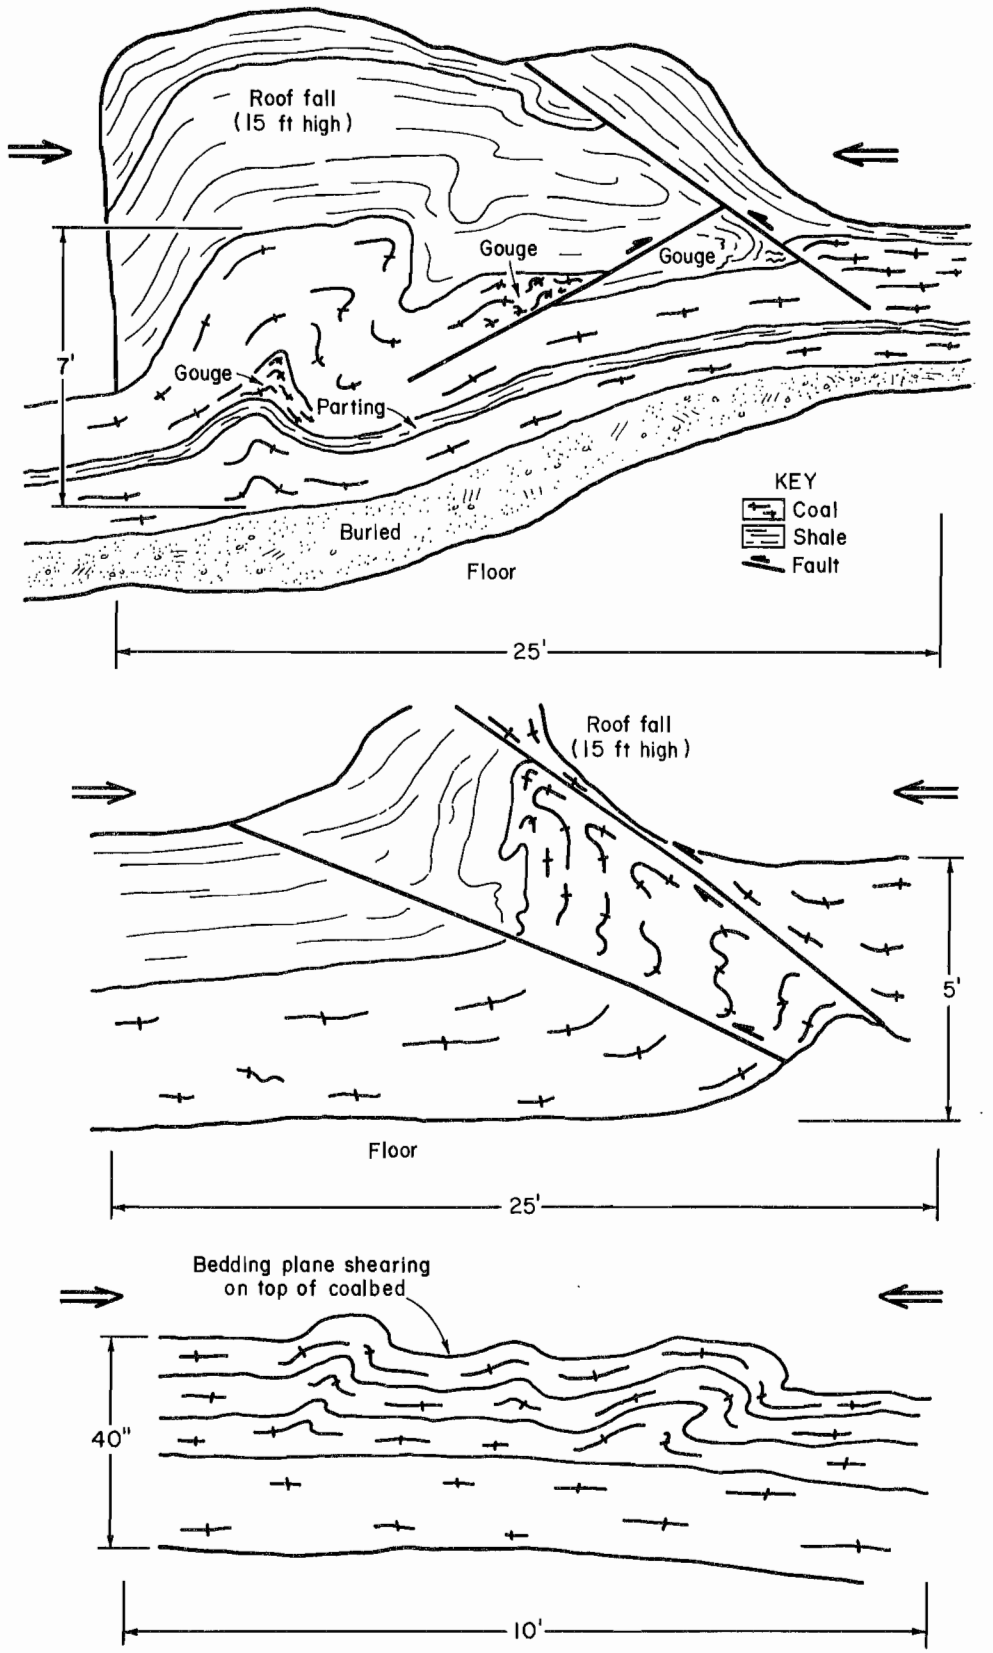
Figure 9.—Thrust faulting and bedding disruption in flats section of Lucerne No. 8 Mine due to horizontal compression.

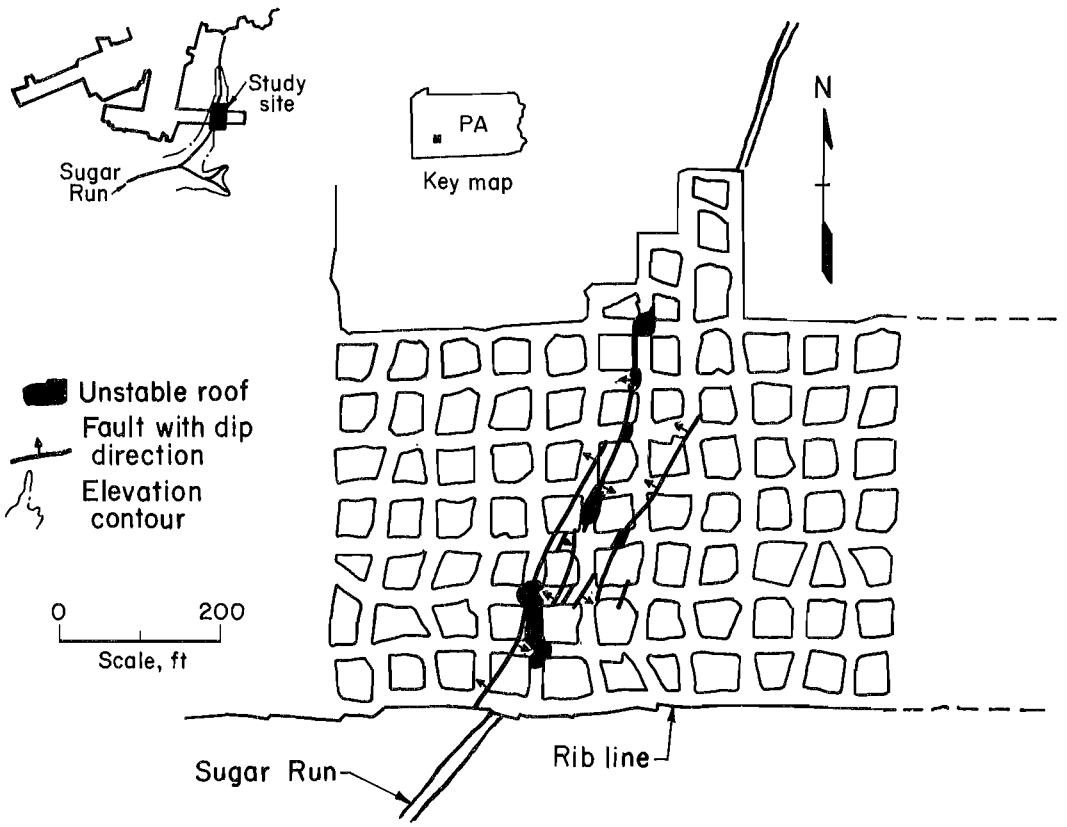
Figure 10.—Map of roof failure beneath Sugar Run at Emilie Mine.

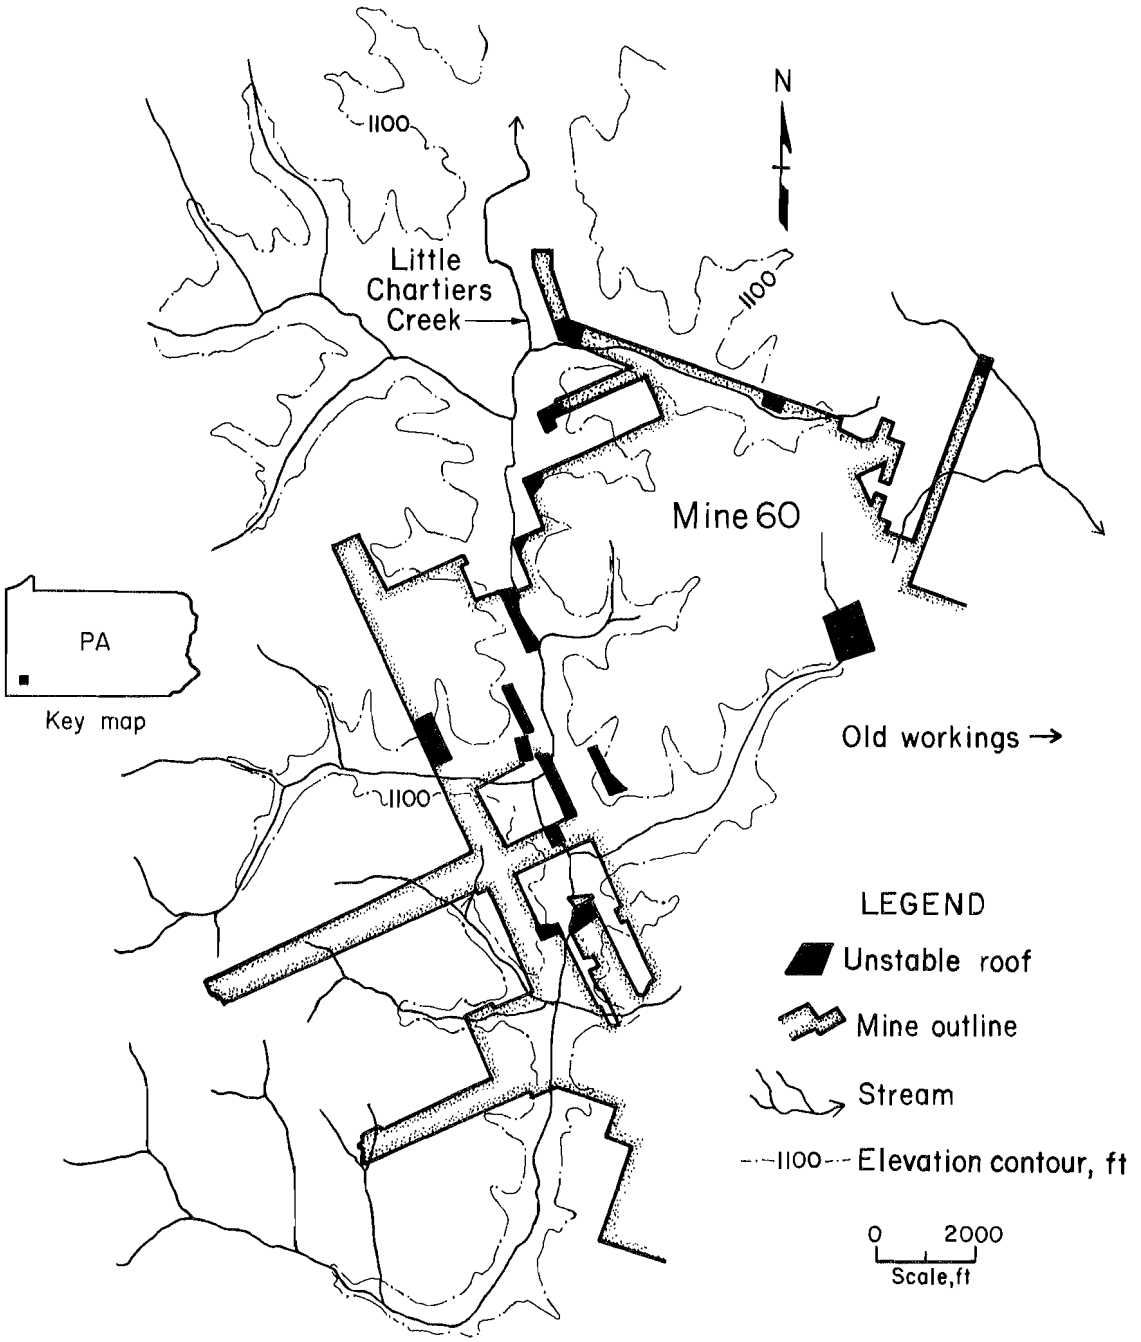
Figure 11.—Mine outline and relationship between unstable roof and surface drainage at mine 60.

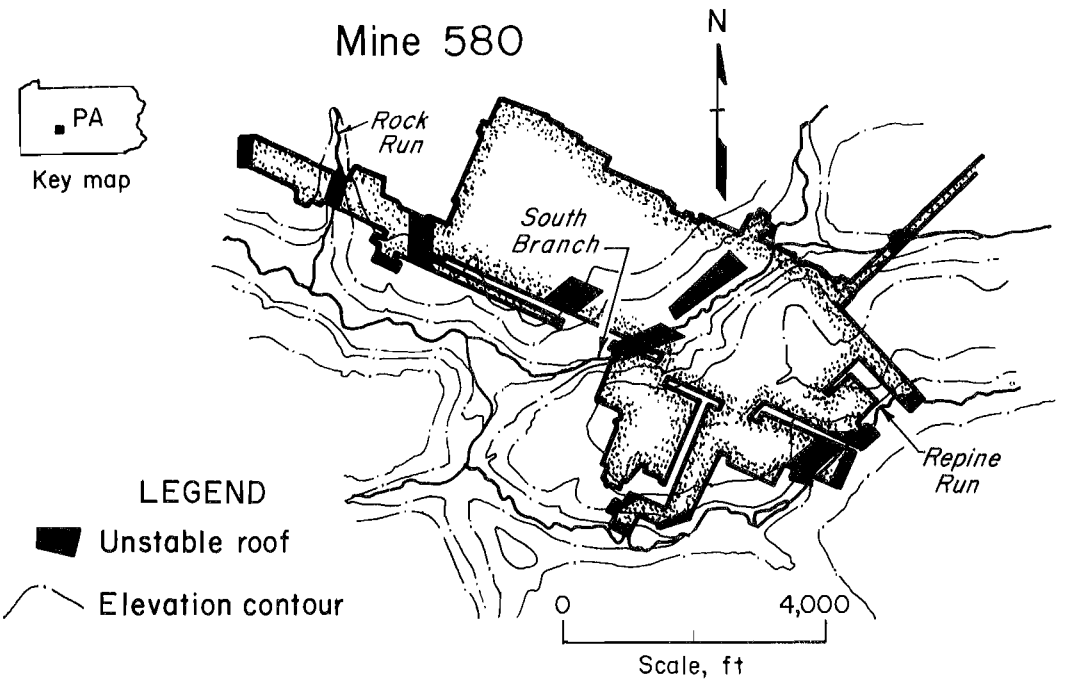
Mine 580 is located in Indiana County, PA and works the Upper Freeport Coalbed (fig. 2). The terrain is gently rolling and relief over the property is up to 250 ft. Figure 12 shows the mine outline and areas of unstable roof. Much of the unstable areas are located beneath the surface drainage. Roof is generally unstable beneath South Branch and especially so beneath Repine Run. The operators feel that roof control will be a problem whenever mining advances beneath Repine Run. Roof control problems include broken and fractured roof, clay veins, slickensides, "rolly shale" (a shale roof member that thins and splits in the roof), soft bottom, and water inflow. The ground control problems at mine 580 are related to poor rock mass quality and not to active stress.

Figure 12.—Mine outline and relationship between unstable roof and surface drainage at mine 580.

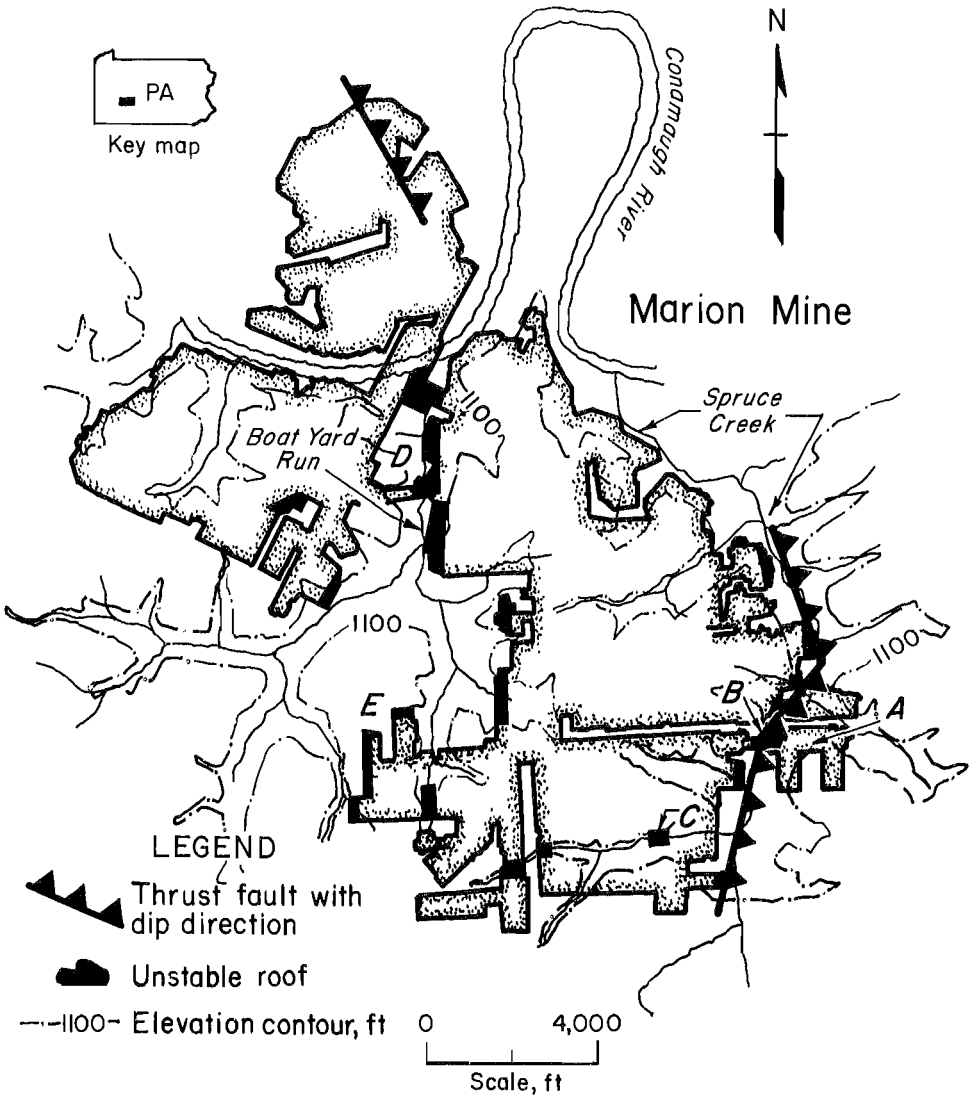
At location A (fig. 13) there is a low-angle thrust fault with a coalbed offset of 1 ft. Figure 14 is a diagram of two separate exposures of the fault. A 3- to 4-in-thick zone of pulverized fault gouge in the coal and roof rock results in unstable roof (fig. 14*A*). Figure 14*B* shows coalbed deformation caused by compression, but the coalbed is only kinked and has not been sheared.

The origin of the Spruce Creek fault zone is unclear. It could be the result of valley stress relief. Thrust faults, observed at the surface in quarries and foundation excavations and created by stress relief, have more structural disturbance and larger throws. Another possibility is that the fault is a larger structural failure which was present before the valley, which controlled the subsequent drainage. The roof beneath the stream valley at location C (fig. 13) are also unstable, with cutter roof the main cause of failure.

The operators are currently attempting to drive two sections to the north between valleys and are having extreme difficulty (fig. 13, location E). The first development to the east was stopped due to long-running falls (18 ft high) occurring outby the belthead, and the second development is currently experiencing severe roof instability. Cutter roof occurs in north running entries, but not in crosscuts. Cutter roof is observed in sandstone as well as shale roof. This is unusual because sandstone usually has much more resistance to deformation than does shale. Unusually high stresses are causing cutter development immediately after

Figure 13.—Mine outline and relationship between unstable roof and surface drainage at Marion Mine.

mining and up to several days after mining. Rails are being used for support and truss bolts are being considered. Angling of entries away from north has had little effect with the cutters just skirting the ribline.

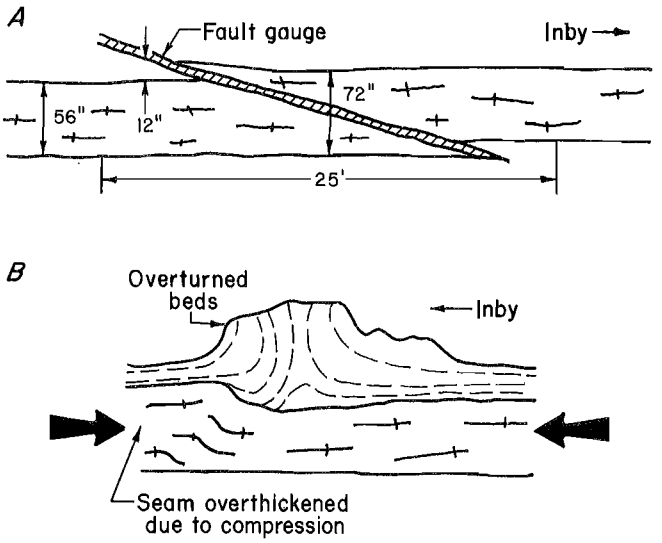
Figure 14.—Thrust faulting and roof disturbance in Spruce Creek fault zone at Marion Mine.

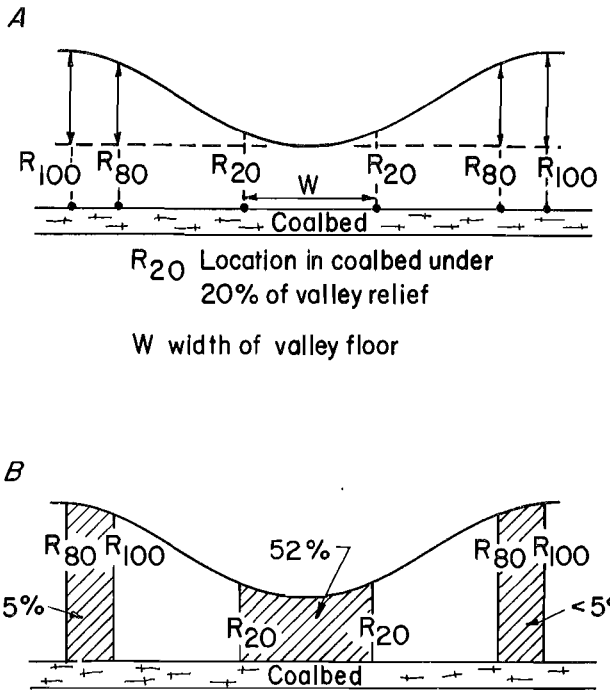
Only 10 pct of the unstable roof was found beneath the valley portion with 80 to 100 pct of the maximum relief (figs. 15-16). There are several possible explanations for this observation. First, valleys may be located preferentially in zones of structural weakness caused by faulting, and this structural disturbance weakens rock strata beneath the valley bottom. This structural alignment, while common to the Allegheny Front is, however, not common in the gently folded Appalachian Plateau region. Second, strata immediately below valley bottoms may be weathered and weakened. Weathering commonly occurs no deeper than 50 ft below surface (*20*). Because unstable roof occurrences are not skewed toward depths that shallow, weathered rock does not appear to be a factor. Third, unusually high stress can develop beneath valley bottoms, causing cutter roof and snap top. These examples of active horizontal stress were not, however, observed beneath many stream valleys in the mines studied. Fourth, poor rock mass quality may result from valley wall loading and lateral stress transfer. These types of failures due to poor rock mass quality have been described previously and are common to the Appalachian region.

Figure 15.—*A*, Valley cross section. Geometric variables used in parametric study; *B*, location of most instances of unstable roof (52 pct) and location of least instances of unstable roof (10 pct).

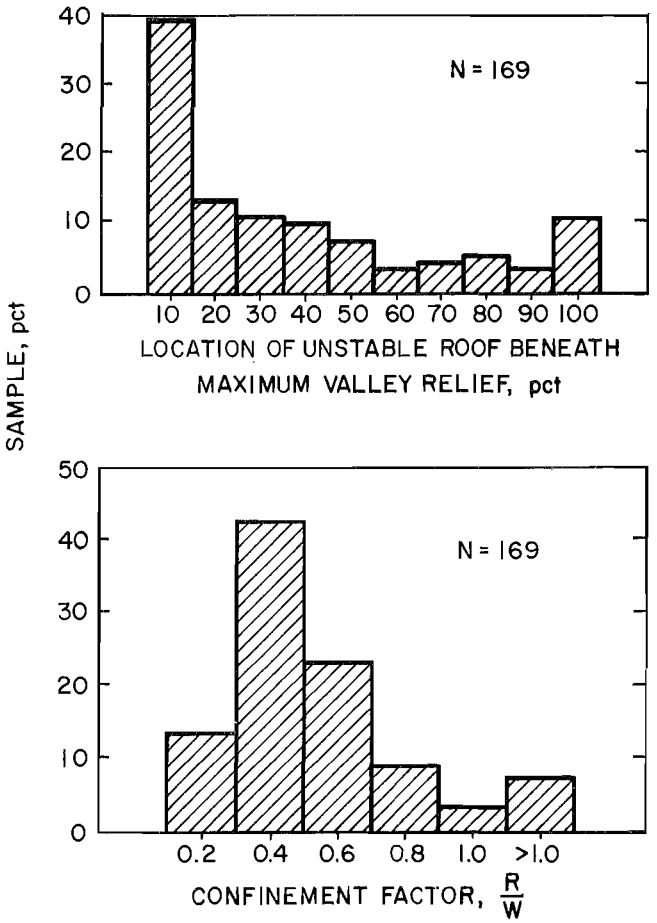
Figure 16.—Distribution of unstable roof with respect to location beneath valley and valley shape.

The relationship between the shape of the valley and all occurrences of unstable roof was also significant. The variable used is the ratio of the height of relief of the associated valley to the width of the valley floor. This ratio also defines the confinement of the valley floor. Sixty-six percent of unstable roof instances occurred beneath valleys with confinement factors between 0.4 and 0.6 (fig. 16). This indicates that unstable roof is more likely to occur beneath broad valleys rather than it is under narrow-floored valleys.

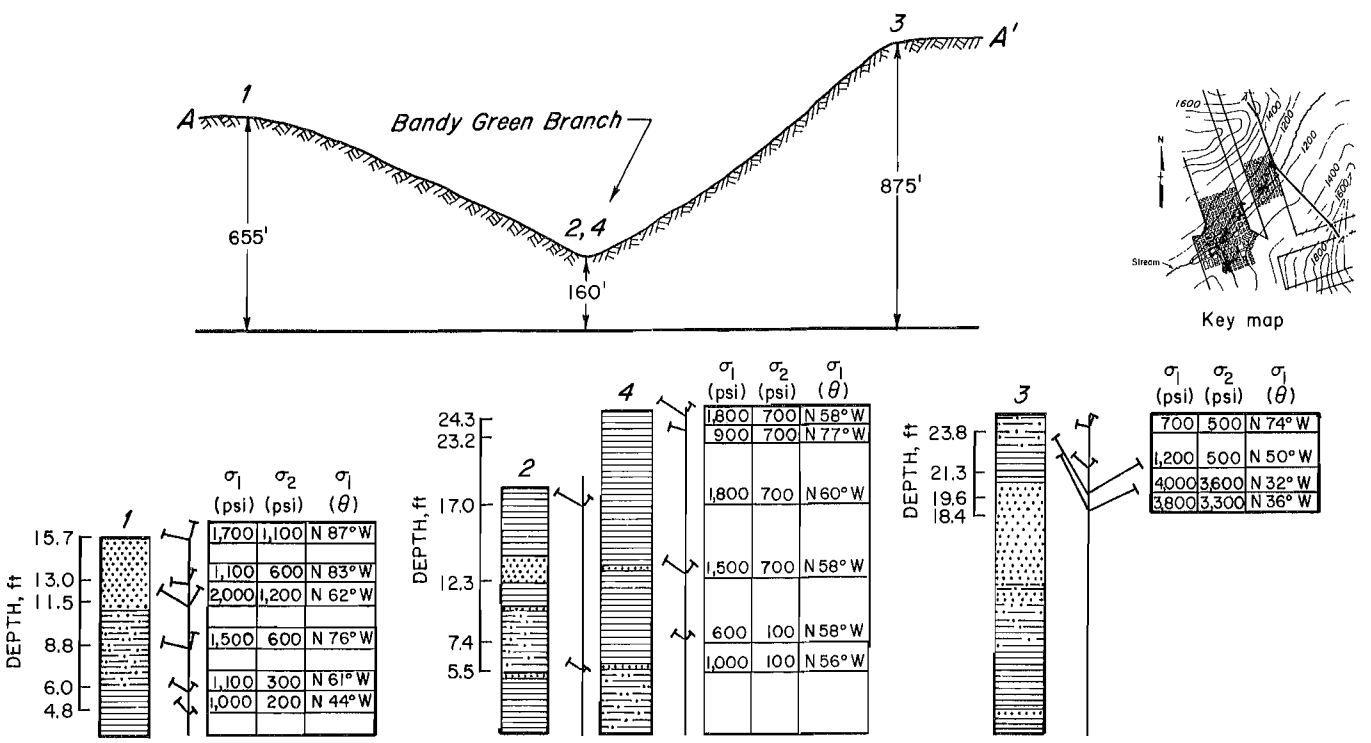
located under each adjacent hillside. These locations were chosen to test the effect of the valley on the horizontal stress field. The Bureau borehole deformation gauge (BDG) and the overcoring method were used. Figure 17 shows the arrangement of boreholes and stress measurements. A total of 16 stress measurements were successful, with the highest measurement taken at 24.3 ft into the roof in hole 4. Several tests were unsuccessful because of core breakage, which contributed to instrument failure. All four holes were drilled within 5 ft of a coal barrier to minimize the effect of the mine opening. The final successful test at hole 1 was at 15.7 ft into the roof. Because this height is still within one opening width of the mine roof, the measurement may be affected by the mine opening. The other three holes were drilled more than 17 ft into the mine roof and these measurements are thought to represent premining horizontal stress.

As the area was stressed regionally, Bandy Green Branch was concurrently downcutting its valley. The removal of confinement (overburden) created a site for the relief of stress beneath the valley and this effect is preserved in the roof rock. The ratio of horizontal-vertical stress beneath holes 2 and 4 (beneath the valley) is 10.2 and 10.4, and between holes 1 and 3 (beneath the hillsides) are 2.8 and 4.1, respectively (table 2). This increased ratio beneath the valley reflects its reduced confinement and the increased potential for valley stress relief failures.

Figure 17.—Horizontal stress measurements in roof strata around Bandy Green Branch Valley.

regional stress. The horizontal stress contributed by the "valley effect" is calculated to be 297 psi by a numerical model (table 3, Valley 9). By removing this stress from the measured value (1,800 psi) the remaining regional stress beneath the valley is 1,503 psi. The difference between calculated regional stress beneath the adjacent hill (3,683 psi) and the calculated regional stress beneath the valley (1,503 psi) is 2,180 psi. This represents the amount of stress relief beneath the valley due to bedding plane faulting.

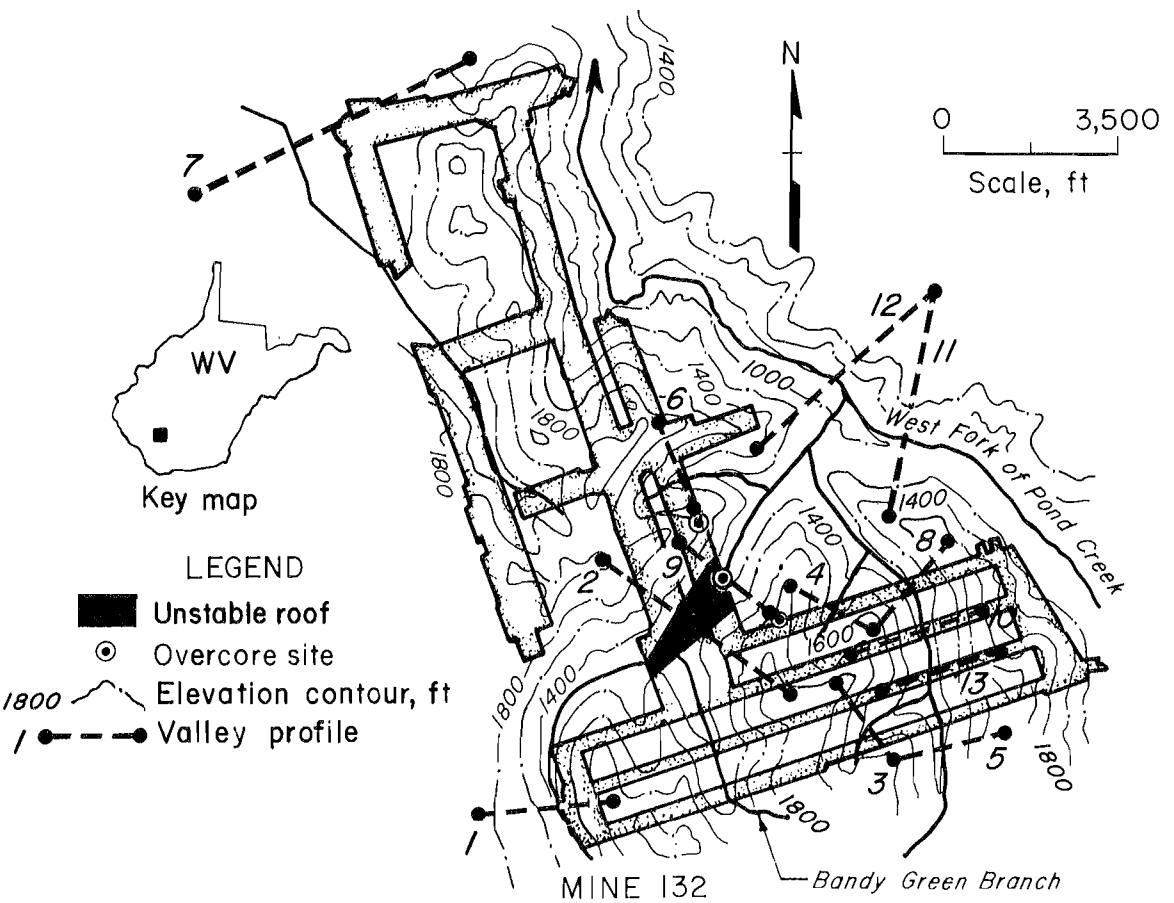
elastic problems as in the case of a valley cross-section. In this analysis of topographic stress effects, 13 different models simulating the 13 different valley cross-sections in figure 18 were run and analyzed. In these models, the finite-difference grids contained an average of 30 elements in the horizontal (X) direction and 22 elements in the vertical (Y) direction. These models were gravity loaded with symmetry boundary conditions on both ends and vertical displacements fixed along the bottom of the grid. The geologic material in the model was assumed to be linear elastic, isotropic, and homogeneous with an elastic modulus of 3,120,000 psi, a Poisson's ratio of 0.30, and a density of 154 pcf. The final results of the 13 model analyses are presented in table 3.

Figure 18.—Valley profiles over mine 132 used in numerical analysis.

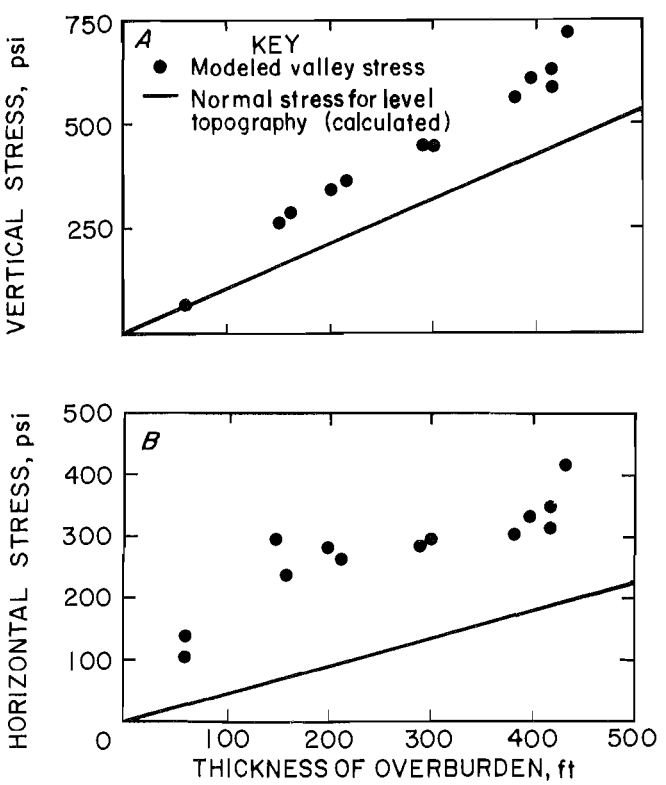
An increase in topography has increased the stress under the valley, as calculated by the FLAC model algorithm. The magnitude and diversity of these stress increases can clearly be seen in figure 19, which present a comparison of the normal and modeled stresses. In some cases, depending on the depth and valley shape, the stress increase is as low as 10 pct; however, in other situations (in particular

the horizontal stress at shallow depths), the stress increase has been as large as 500 pct. These figures illustrate the stress increases caused by the valley topography. It is apparent that knowledge of the magnitude of this stress increase could be critical to mine design under these valleys.

Figure 19.—Comparison between modeled stress at mine level under valleys at mine 132 and theoretical stress for level topography. *A*, Vertical; *B*, horizontal.

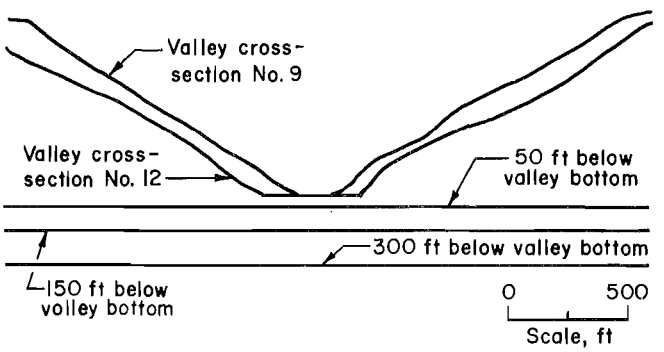
A closer examination of the stresses calculated by the finite-difference models can provide some insight into the effect of the depth and the valley geometry on the topographically induced stress field at mine 132. Figure 20 shows the actual cross sections of Valleys No. 9 and No. 12 with three coal seams simulated at depths of 50, 150, and 300 ft below the valley floor. Figure 21 shows the horizontal (sxx) and vertical (syy) stresses along the three different seams under Valley No. 9 as calculated by the FLAC model. Examination of the horizontal stress curves reveals that they do not decrease as the overburden decreases under the valley, as would be expected. Rather, the horizontal stress is actually concentrated under the valley at the two greater depths.

Figure 20.—Cross section of Valleys No. 9 and No. 12 with simulated coalbed horizons at mine 132.

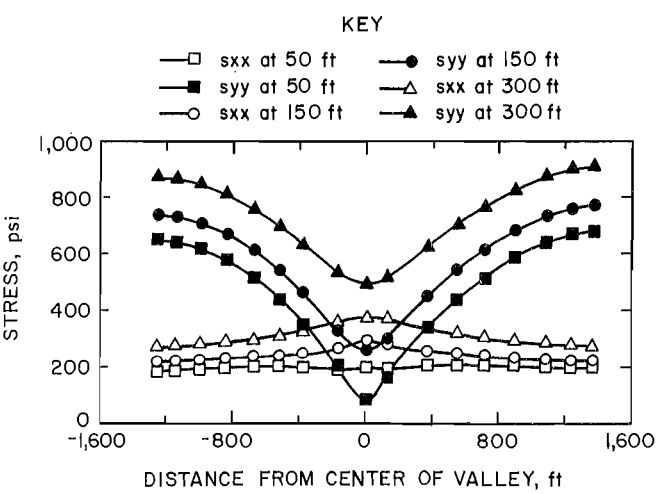
This stress concentration is actually a result of the two ridges pushing toward the valley center. The lack of horizontal stress increase at the 50-ft level is a result of this area being on the border of a horizontal stress-relief zone generated under the valley bottom. A look at the vertical stresses in figure 21 also reveals some interesting observations. The vertical stress does indeed decrease as the overburden decreases towards the center of the valley; however, the magnitude of this decrease is diminished at the greater depths. This lack of stress reduction is the result of the weight of the ridges being spread over a larger area as the depth increases. Theoretically, at some depth, the effect of topography on vertical stress becomes zero.

The final observation from figure 21 is that at the two shallower depths, 50 and 150 ft, the horizontal stress is greater than the vertical stress calculated beneath Valley No. 9. Through geologic time, this higher horizontal stress would be expected to cause compressional features such as bedding plane slips or small thrust displacements. This model provides a mechanism for the compressional roof failures observed beneath Bandy Green Branch at the 160 ft depth. Horizontal compression exceeded confining pressure from overburden and overcame cohesion along bedding planes. Possibly, at 300 ft beneath this valley vertical pressure would be sufficient to confine compression and prevent horizontal slippage. Table 3 shows several

Figure 21.—Horizontal (sxx) and vertical (syy) stresses at various horizons below apex of Valley No. 9 at mine 132.

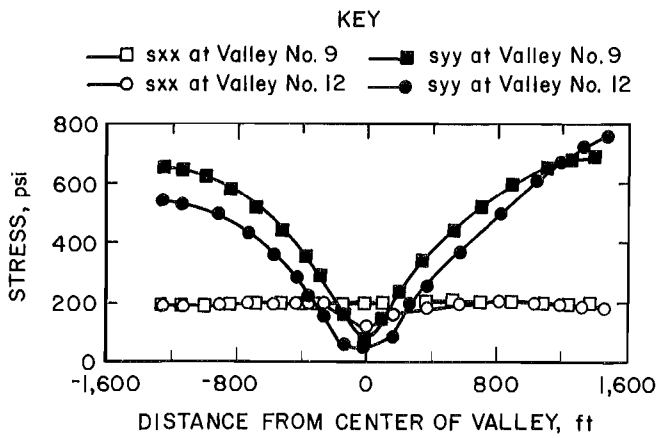
To investigate the effect of the valley shape on the stress field, figures 22 and 23 present comparisons of the horizontal and vertical stresses at identical depths under Valleys No. 9 and No. 12 (fig. 18). All the valleys investigated in this study had similar slopes and relief; therefore, the only factor which is truly different between Valleys No. 9 and No. 12 is the width of the valley floor (100 ft for Valley No. 9 and 350 ft for Valley No. 12). This difference in valley floor width distinctly influences the horizontal stresses (sxx) at the 50-ft level where the stresses show a decided drop under Valley No. 12 (fig. 22). This drop in horizontal stress at the center of Valley No. 12 is a result of the wider valley bottom which generates a larger stress-relief zone that encompasses the 50-ft level under Valley No. 12, whereas the stress-relief zone under Valley No. 9 did not encompass the 50-ft level.

Figure 22.—Comparison of stress between Valleys No. 9 and No. 12 at mine 132 at 50 ft deep.

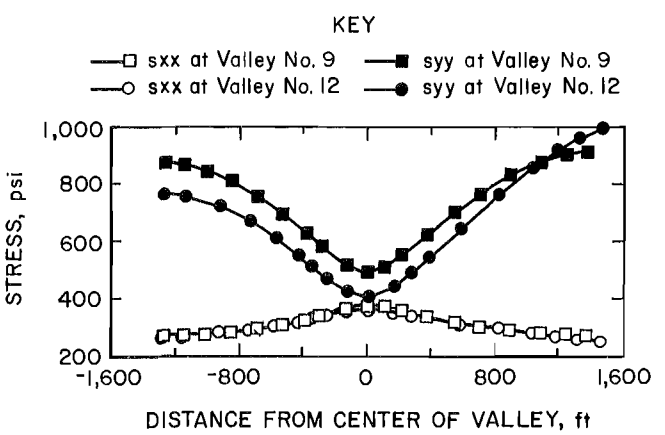
Figure 23.—Comparison of stress between Valleys No. 9 and No. 12 at mine 132 at 300 ft deep.

Examination of the horizontal stresses in figure 23 shows that the effect of the horizontal stress-relief zone at 300 ft below the two valleys is negligible and therefore, the curves are practically superimposed. At this depth, the difference in the shape of the two valleys makes no difference in their effect on horizontal stress, although there is still a "valley effect" horizontal stress concentration due to overburden removal. Figure 24 is the same comparison of stress beneath Valleys No. 9 and No. 12 with stresses modeled at 500 ft. The stress concentration beneath the valley floor remains, but appears to be diminishing.

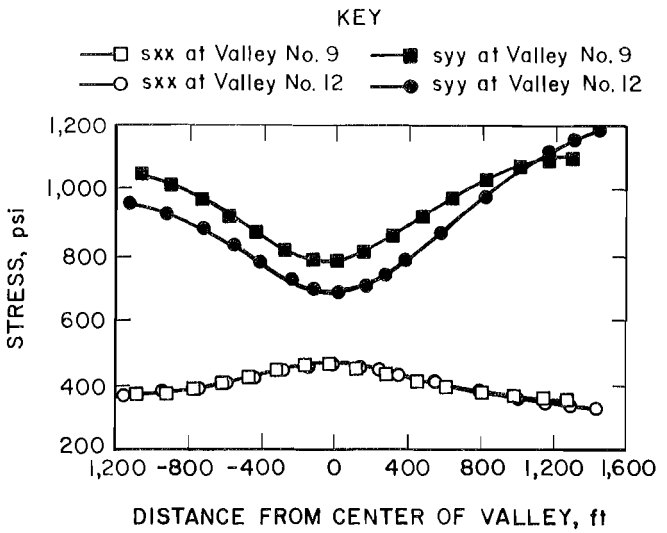
Figure 24.—Comparison of stress between Valleys No. 9 and No. 12 at mine 132 at 500 ft deep.

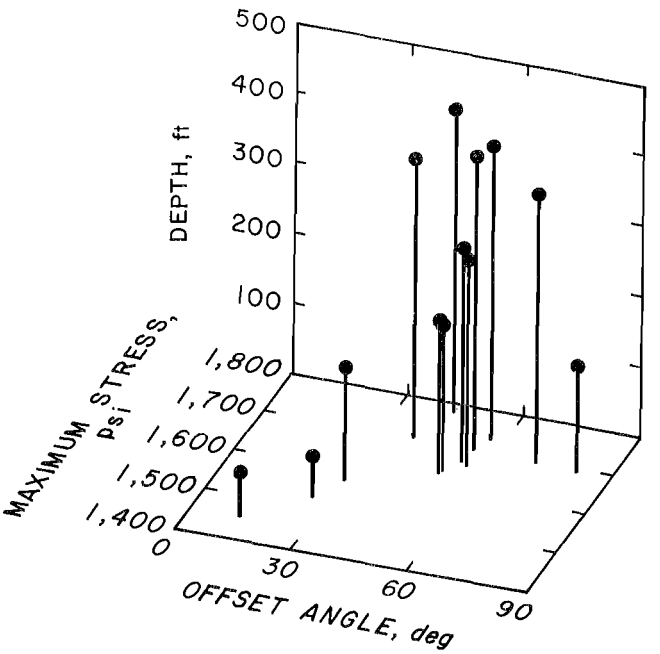
Figure 25.—Three-dimensional graph showing increase in maximum horizontal stress with offset angle and depth of valleys above mine 132.

Figure 25, a three-dimensional plot of maximum horizontal stress plotted against offset angle and depth, aids in the visualization of the interactive effect of both the offset angle and the depth. From this figure, the maximum horizontal stress does indeed increase with both the offset angle and depth as presumed. Therefore, when the regional stress is considered, not only does the shape of the valley influence the stress field, but so does the orientation of the valley with respect to the direction of the principal regional stress.
