REPORT OF INVESTIGATIONS/1992

Effects of Horizontal Stress Related to Stream Valleys on the Stability of Coal Mine Openings

Report of Investigations 9413

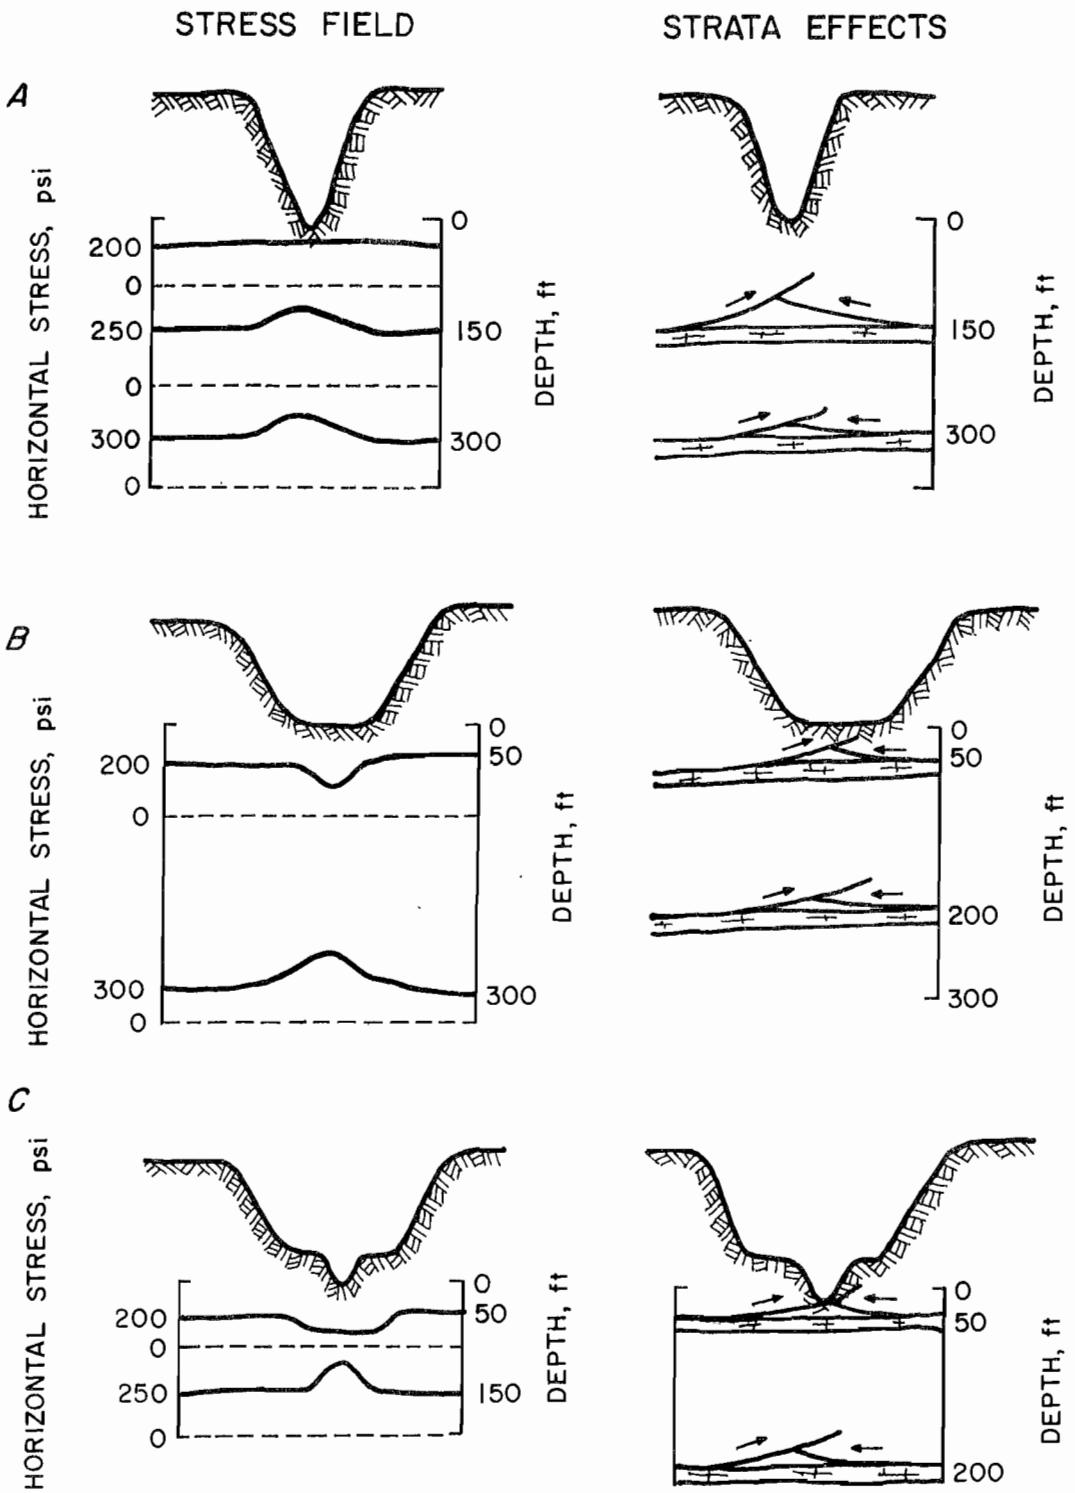
The valleys forming the watershed above mine 132 are in various stages of evolution, with the West Fork of Pond Creek being the most mature. The state of stress at the coal seam level beneath them depends on the shape of the valley, the depth of cover, and the orientation of the valley with respect to the principal regional stress. The relative risk of compressional failure based on shear stress is given in table 5. Finally, perhaps the most important factor in whether failure will occur, given the necessary stresses, is the shear strength of the roof sequence. This important factor is difficult to measure or estimate because of the infinite variety and character of the many bedding planes and interfaces which makeup coal measure rocks.

Figure 26.—Representation of modeled stress field and roof effects beneath Valleys No. 9 and No. 12. *A*, Valley No. 9; *B*, Valley No. 12; *C*, rejuvenated Valley No. 12.
